**DEPARTMENT OF TRANSPORTATION****DIVISION OF ENGINEERING SERVICES**

Contract #: 04-0120F4Cty: SF/ALA Rte: 80 PM: 13.2/13.9File #: 69.28**WELDING INSPECTION REPORT****Resident Engineer:** Pursell, Gary**Address:** 333 Burma Road**City:** Oakland, CA 94607**Report No:** WIR-000872**Date Inspected:** 18-Nov-2007**Project Name:** SAS Superstructure**OSM Arrival Time:** 1400**Prime Contractor:** American Bridge/Fluor Enterprises, a JV**OSM Departure Time:** 2330**Contractor:** Zhenhua Port Machinery Company, Ltd (ZPMC), Changxing Island **Location:** Shanghai, China**CWI Name:** Fu Yuhong**CWI Present:** Yes No**Inspected CWI report:** Yes No N/A**Rod Oven in Use:** Yes No N/A**Electrode to specification:** Yes No N/A**Weld Procedures Followed:** Yes No N/A**Qualified Welders:** Yes No N/A**Verified Joint Fit-up:** Yes No N/A**Approved Drawings:** Yes No N/A**Approved WPS:** Yes No N/A**Delayed / Cancelled:** Yes No N/A**Bridge No:** 34-0006**Component:** Deck & 77 meter mock ups**Summary of Items Observed:**

## WELDING INSPECTION REPORT

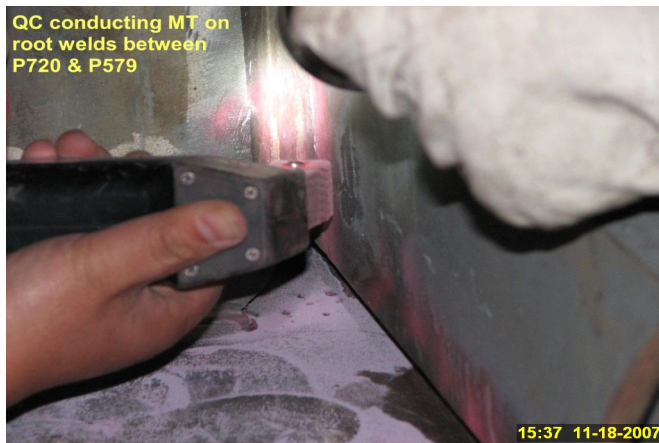
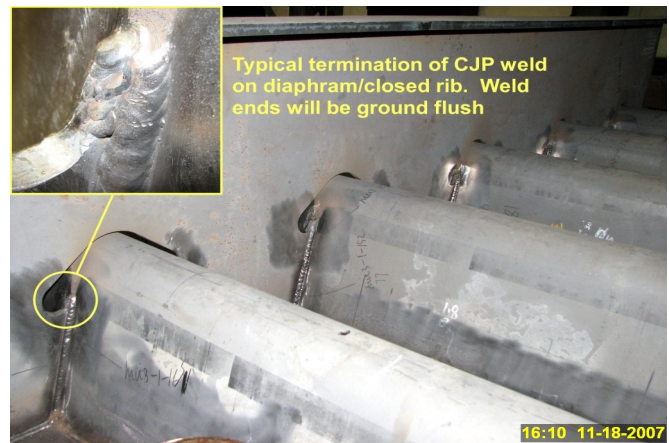
The QA inspector was also informed of excavations on the 77 meter mock up, skin plate stiffener MA2-3. The QA inspector was notified that QC MT inspection has been conducted and the ZPMC liason person Fu Yuhong asked the QA inspector to conduct a verification MT on the excavations. The QA inspector was informed that QC conducted ultrasonic testing on these welds and rejectable indications had been removed. The QA inspector asked to review the UT report that indicated where the rejectable indications were located. Upon review of the report, the QA inspector asked the QC inspector Fu Yuhong if any QC inspectors have verified that the indications were removed. The QA inspector noted that the rejectable indications written on the UT report appear to be at different depths and X axis locations than the weld excavations currently measure. The QC inspector reviewed the UT report and could not provide answers to the QA inspector. The QA inspector then informed the QC inspector that verification of the excavations could not be conducted at this time.
